# 7 AQUATICS

# CHAPTER 7 SUMMARY

# RAPID CITY AQUATICS SUMMARY

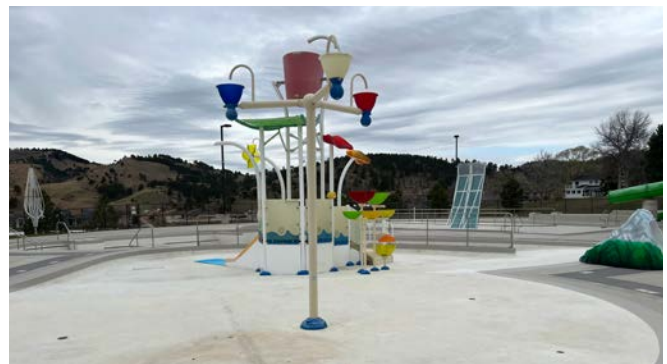
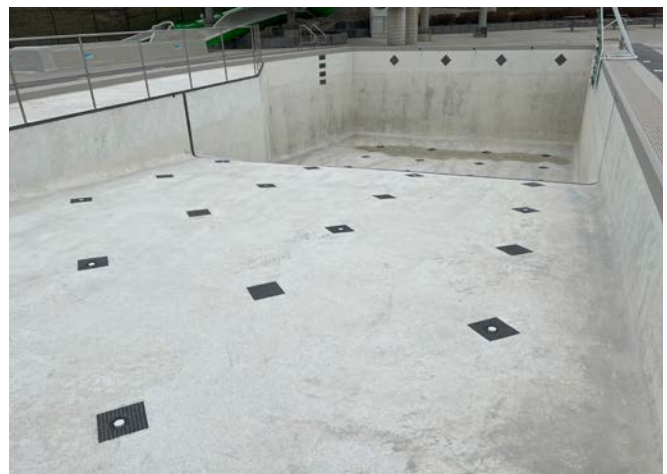
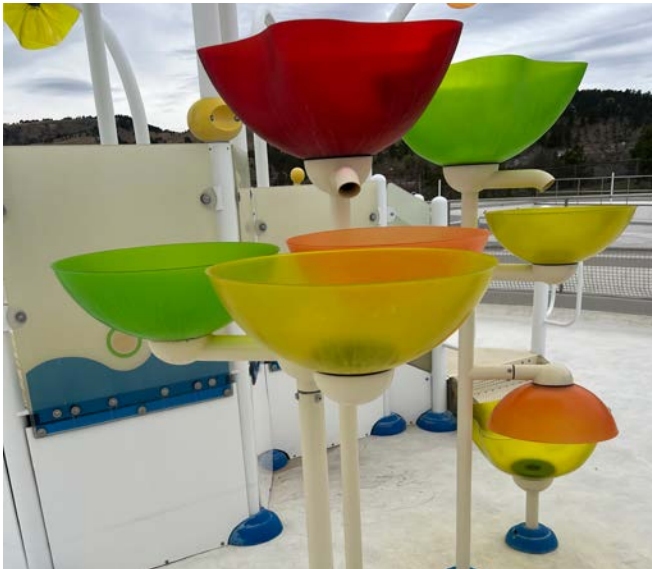
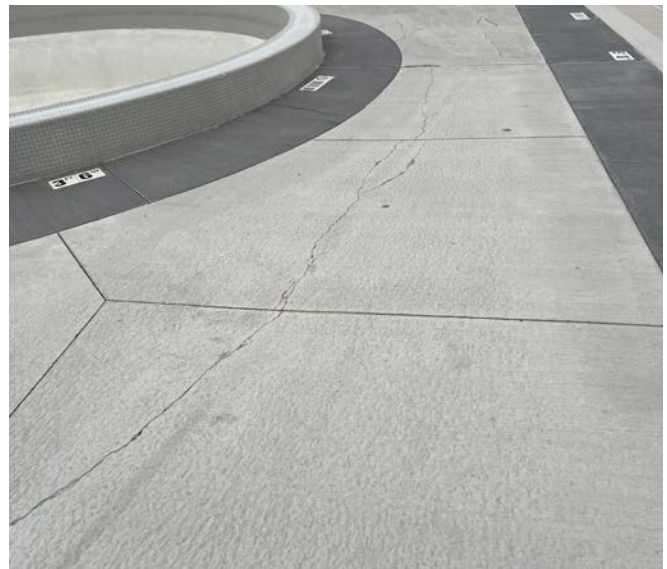
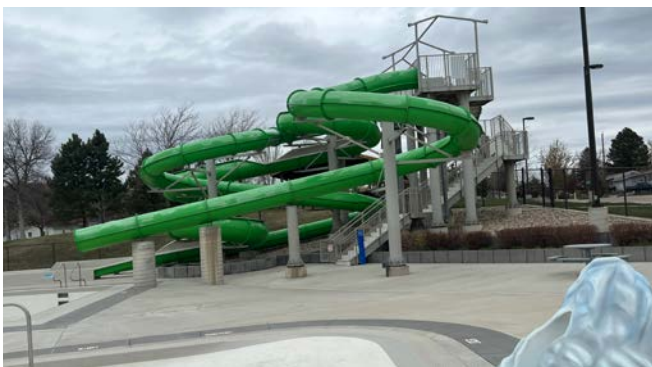
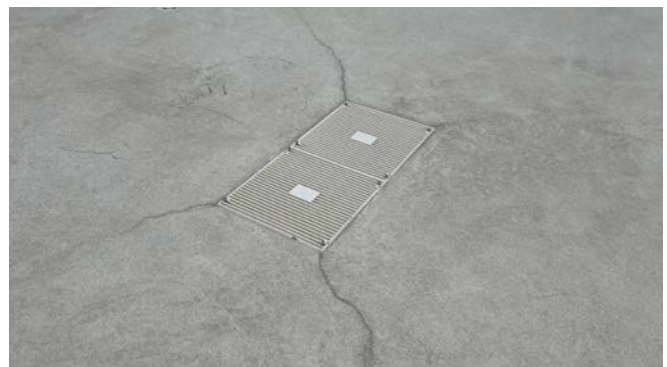
- The swimming pool structures were constructed on piers, while the pool deck was not- allowing the pool deck to move differentially from the pool structures. There is some cracking and differential movement on the pool deck.
- The recreational pool has a significant amount of shrinkage cracks in the structure which are reflecting through the pool coating.
- The epoxy resinous floor in the bathhouse appears very dingy. Staff can't get the coatings fully clean.
- The breezeway has a coating with flakes in the surface. It initially has the appearance of an epoxy resinous flooring, but upon closer review it appears very thin and more resembles a paint coating.

- The aquatic play unit is in fair condition, although some portions have worn. Staff has replaced original netting with solid panels. Staff also reports that the acrylic components are not very resistant to hailstorms, which has damaged some to the point they have been replaced.

- Replaster the pool, repair cracks in pool shell
- Consider replacing the play structure (APU)
- Plan for replacing the pool deck – future
- Replace floor coating in bathhouse
- Recoat bathhouse entry breezeway floor coating
- Refinish waterslide flume surfaces

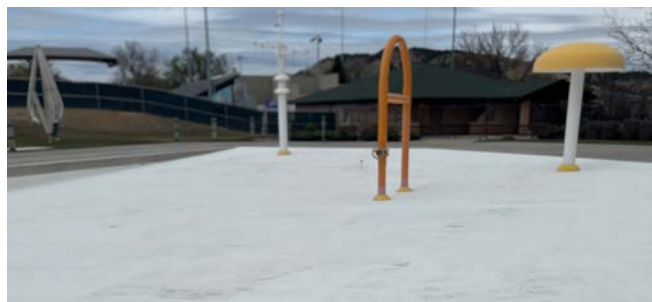
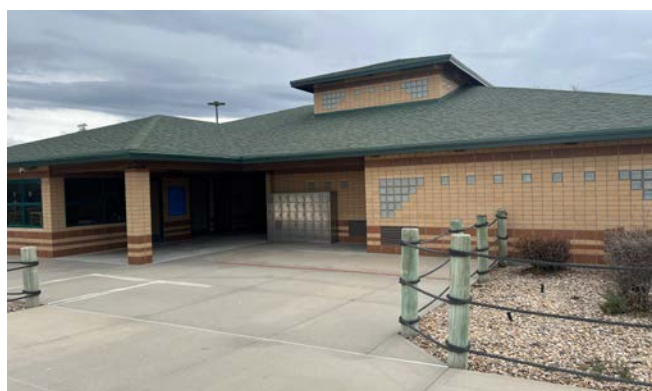
- Staff believes that each of the two pools could be losing a significant amount of water.
- The stainless-steel gutter is approximately 25 years old, and requires annual welding and repair. Converter boxes are often a weak link, and could be cause for water loss.
- The pool deck has moved significantly. It appears to have settled in some areas and heaved in other spots. Some locations have been ground to mitigate offsets and trip hazards.

- Recoat the pool basin
- Replace the stainless steel gutter system
- Replace the pool deck along with gutter system
- Plan for filter replacement
- Refresh bathhouse interior
- Recoat the water slide tower support structures

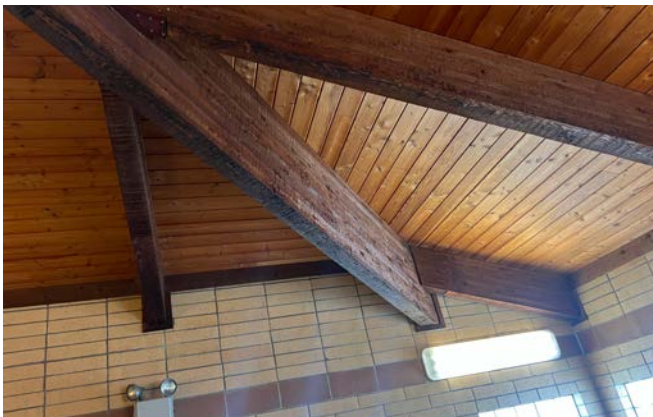
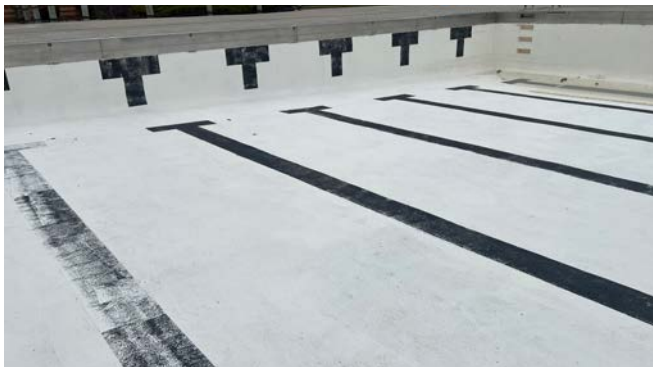
- The floor appears to have an epoxy-resinous flooring which has worn and is dingy.
- The filter system is older and approaching the end of life. While there are no signs of immediate failure, we anticipate no more than 5 to 10 years remaining service life.
- The bathhouse could use a “freshen up” to make it more appealing and inviting to the guests. In particular, lighting and floor coatings could be replaced and would make the space more inviting.
- The pool heaters are original, and have been rebuilt. They are also reaching end of their service life.
- The painted pool surface has worn. Staff has scheduled the pool to be plastered in 2027.
- The coating on the water slide tower and columns has worn.

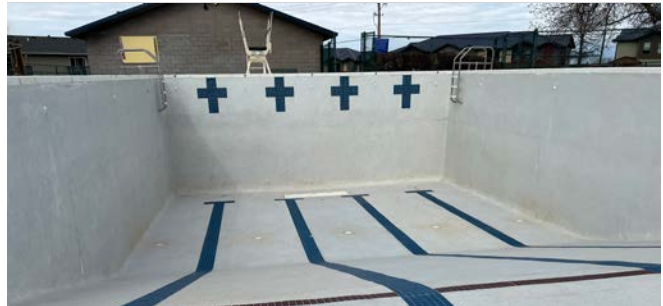
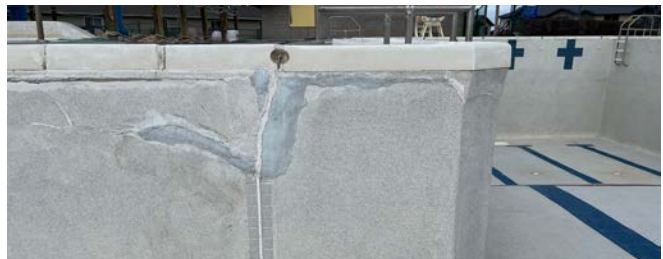
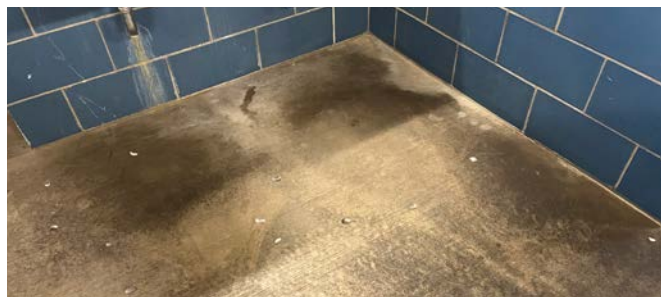
- There are a few locations in the pool structure that have stress cracking and in need of repair- including along the top of the wall in the diving, and on the interior corner wall between the laps and diving.
- A few locations in the gutter blocks need to be reset onto the wall with a new mortar bed.

- The pool deck has moved significantly. It appears to have settled in some areas and heaved in other spots. Some locations have been ground to mitigate offsets and trip hazards.
- The cmu block includes bands with glazed faces. The faces have spalled off of many of the blocks on the dressing room entry screen wall.

- Repair portions of the pool structure
- Repair portions of the precast gutter (check that gutter blocks still available)
- Recoat the pool basin
- Repair glazed block face on screenwall? Or remove and replace- perhaps with different materials
- Redo bathhouse floor
- Replace the filter
- Renovate slide tower rails and treads

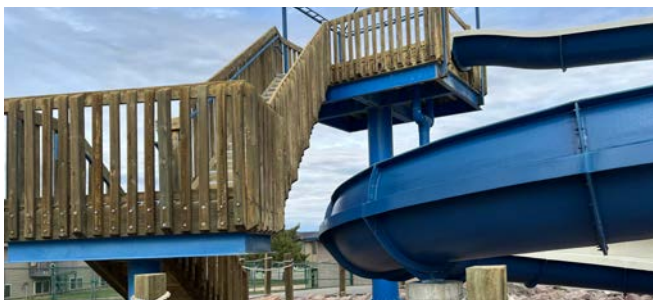
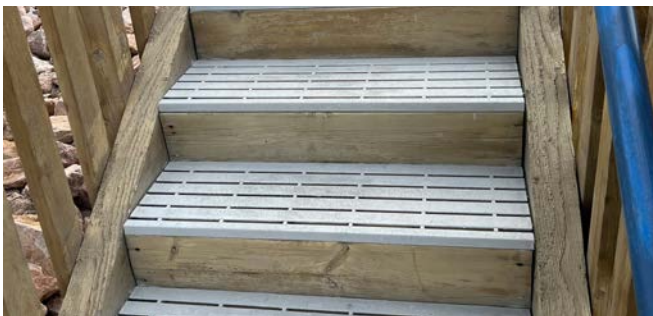
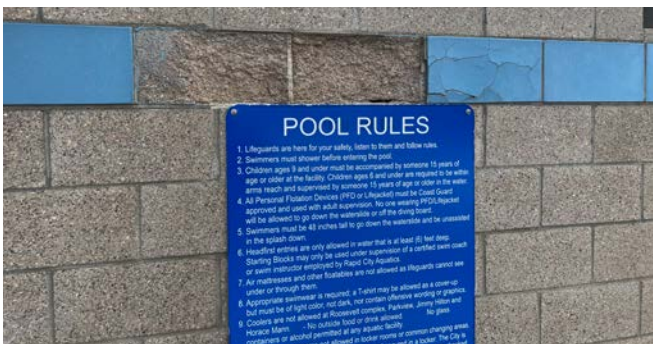
- The exposed aggregate plaster coating is original and has worn. It is scheduled to be replastered soon.
- The bathhouse lighting could be updated.
- The floor is broom finished concrete and is dingy- which could be addressed. There may not be enough floor slope and drainage.
- The filter system is older and approaching the end of life. While there are no signs of immediate failure, we anticipate no more than 5 to 10 years remaining service life.
- The fiberglass flume appears to be in good condition, but the tower structure includes wood railings that have weathered. The railings and tower treads are scheduled for replacement soon.

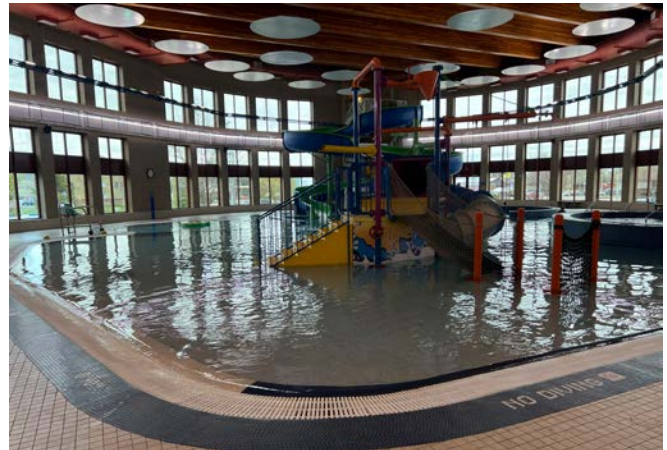
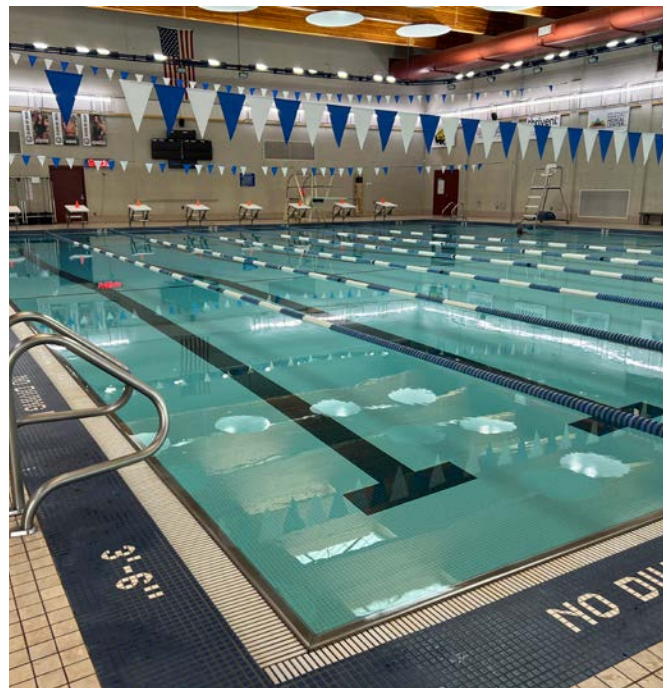
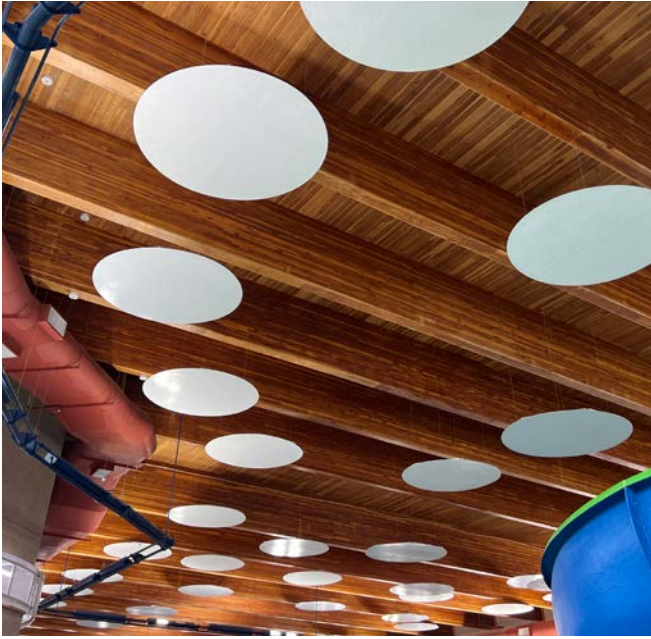
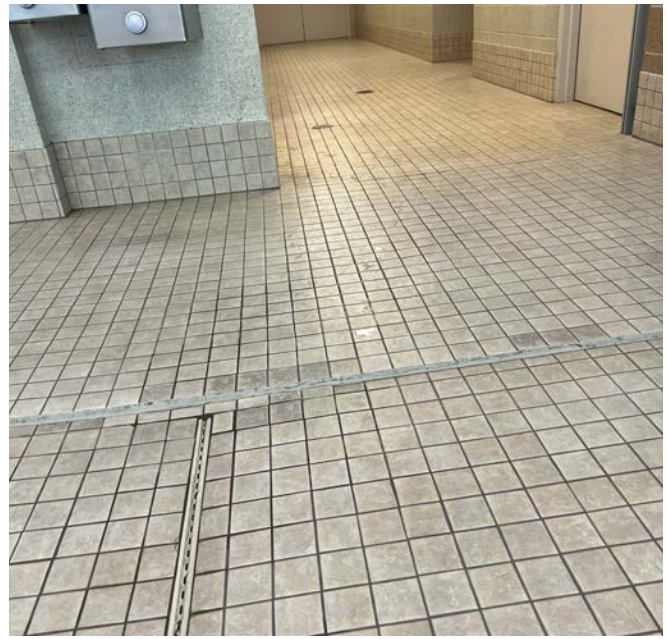
- The swimming pool structures were constructed on piers, while the pool deck was not- allowing the pool deck to move differentially from the pool structures. Settlement of pool deck, causing offsets and issues in deck tile. Staff has done an admirable job in fixing and adjusting tiles and offsets as they develop - replacing tiles each year.
  - *There seems to be a couple of possible known likely causes for the deck movement, each relating to granular fill placed over softer native soils. Regardless of the cause, the pool deck has settled as much as 1" to 1 ½".*

- Some piping has sheared and broken, presumable from stress exerted by the settling of the deck and subgrade. The locations of failure have been where pipes extend through building footings into the pump pit.
- Slippery deck tile. Tiles are 2" square and have a fairly smooth top texture.
- Access hatches in deck have bound, making it difficult to open for maintenance staff.
- Stainless steel hangers/cables under tension near the ceiling are susceptible to stress corrosion cracking due to the exposure to warm chlorine-laden air. It can result in cracking and pitting stainless steel under tension and result in sudden brittle failure. Staff reports that they have replaced some hangers in recent past that appear to have failed and continue to monitor them.

- **Replace pool deck**
  - Have corings/borings performed / get geotechnical investigation and recommendations
  - Remove and replace pool deck per geotechnical engineer recommendations. Decide upon floor type – tile, epoxy resinous, broom finished concrete
  - Replace below-deck piping when deck is removed to start life-cycle and correct any damage from additional stress exerted from settlement/shifting.
- **Remove and replace access hatch**
- **Consider inspection of stainless steel hangers-** could result in recommendations to replace all. Or continue current process of inspecting and replacing. Risk is that failure can be sudden. If one breaks not an issue. If one breaking causes chain reaction, whole supported items can fall unexpectedly.
- **Prepare for filter replacement within 10 years.**
- **Ongoing pump and pool equipment maintenance and replacement.**
