# 7 AQUATICS

# CHAPTER 7 SUMMARY

# RAPID CITY AQUATICS SUMMARY

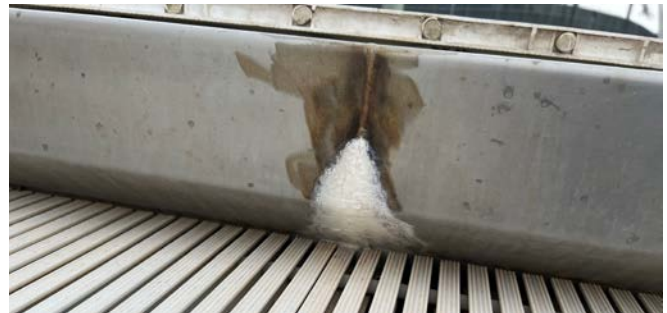
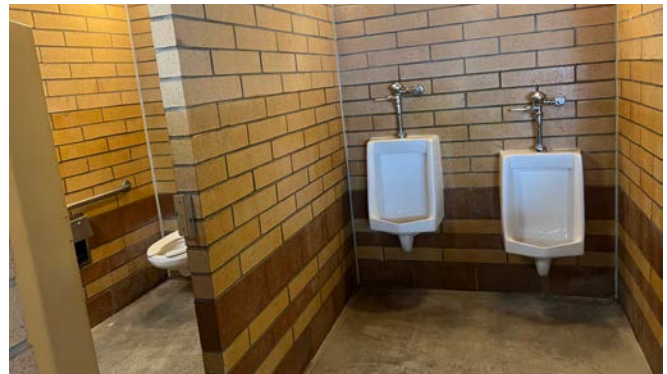
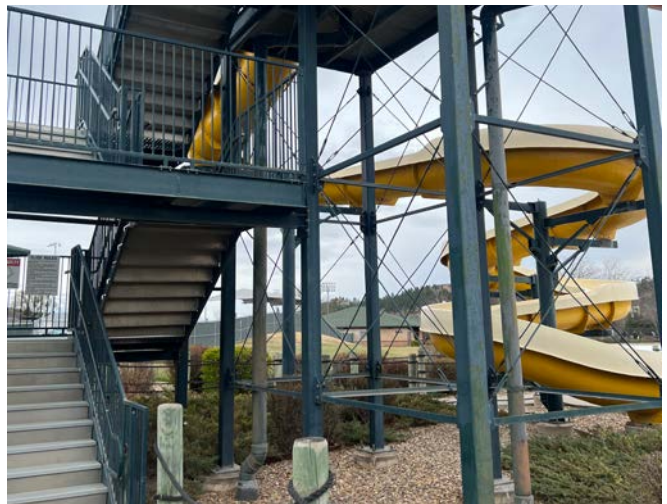
- Staff believes that each of the two pools could be losing a significant amount of water.
- The stainless-steel gutter is approximately 25 years old, and requires annual welding and repair. Converter boxes are often a weak link, and could be cause for water loss.
- The pool deck has moved significantly. It appears to have settled in some areas and heaved in other spots. Some locations have been ground to mitigate offsets and trip hazards.

- The floor appears to have an epoxy-resinous flooring which has worn and is dingy.
- The filter system is older and approaching the end of life. While there are no signs of immediate failure, we anticipate no more than 5 to 10 years remaining service life.
- The bathhouse could use a “freshen up” to make it more appealing and inviting to the guests. In particular, lighting and floor coatings could be replaced and would make the space more inviting.
- The pool heaters are original, and have been rebuilt. They are also reaching end of their service life.
- The painted pool surface has worn. Staff has scheduled the pool to be plastered in 2027.
- The coating on the water slide tower and columns has worn.

- Recoat the pool basin
- Replace the stainless steel gutter system
- Replace the pool deck along with gutter system
- Plan for filter replacement
- Refresh bathhouse interior
- Recoat the water slide tower support structures

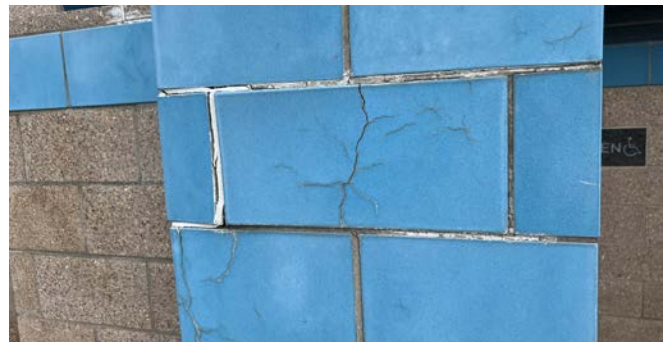
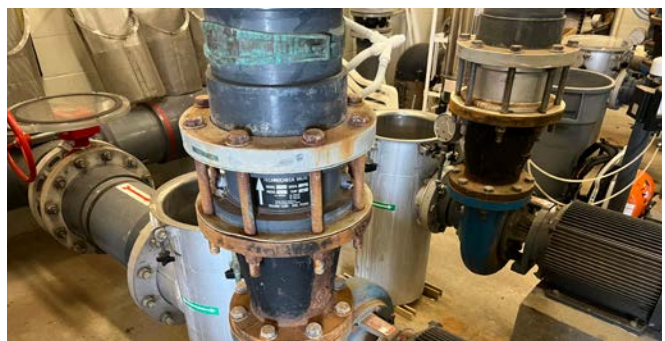
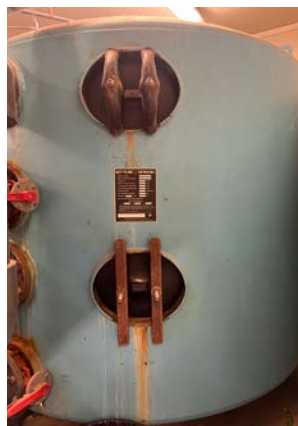
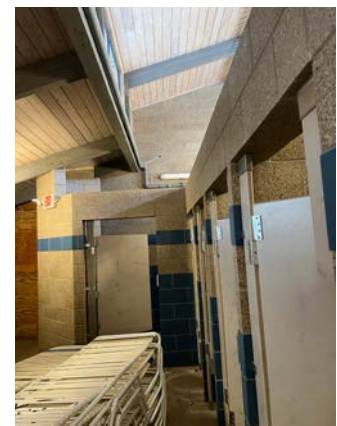
- There are a few locations in the pool structure that have stress cracking and in need of repair- including along the top of the wall in the diving, and on the interior corner wall between the laps and diving.
- A few locations in the gutter blocks need to be reset onto the wall with a new mortar bed.

- The pool deck has moved significantly. It appears to have settled in some areas and heaved in other spots. Some locations have been ground to mitigate offsets and trip hazards.
- The cmu block includes bands with glazed faces. The faces have spalled off of many of the blocks on the dressing room entry screen wall.

- The exposed aggregate plaster coating is original and has worn. It is scheduled to be replastered soon.
- The bathhouse lighting could be updated.
- The floor is broom finished concrete and is dingy- which could be addressed. There may not be enough floor slope and drainage.
- The filter system is older and approaching the end of life. While there are no signs of immediate failure, we anticipate no more than 5 to 10 years remaining service life.
- The fiberglass flume appears to be in good condition, but the tower structure includes wood railings that have weathered. The railings and tower treads are scheduled for replacement soon.

- Repair portions of the pool structure
- Repair portions of the precast gutter (check that gutter blocks still available)
- Recoat the pool basin
- Repair glazed block face on screenwall? Or remove and replace- perhaps with different materials
- Redo bathhouse floor
- Replace the filter
- Renovate slide tower rails and treads

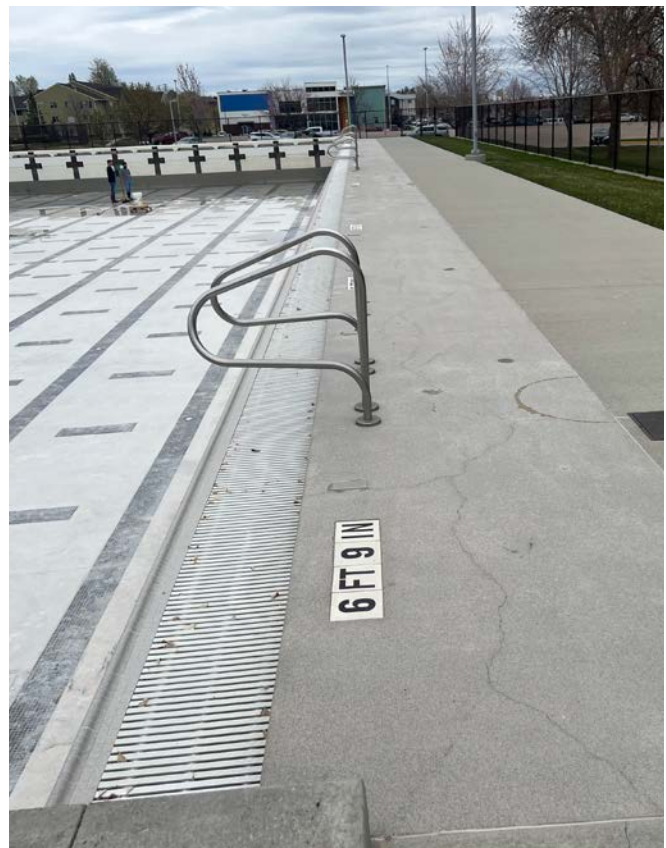
- Replacement of the exposed aggregate plaster finish
- Fiberglass gel coating on bulkhead has worn and in need of recoating.

- Replace pool deck
- Replace pool coating
- Replace pool heater
- Refinish fiberglass bulkhead
- Cover outdoor pool
